Manhole Inspection Summary

Manhole # S3300_012MH

Insp Date: **9/15/08 9:52 AM**

Location Address: **2222 HOWARD ST**

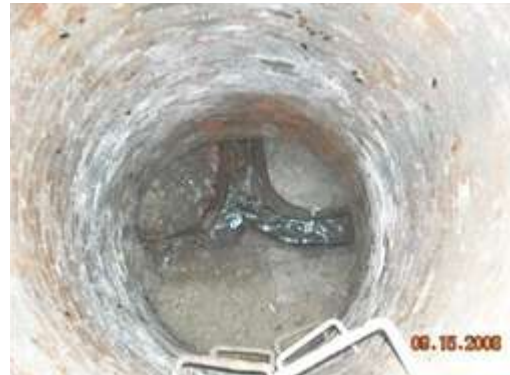
Top View

Adjustment, Corbel and Barrel infiltration.
Corroded steps. Bench and Channel
debris.

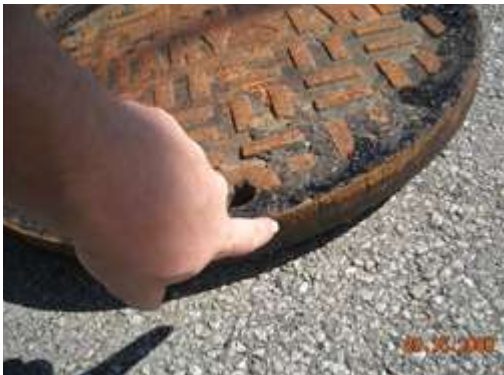
Defect

Condition: **Cracked**

Cracked lid.

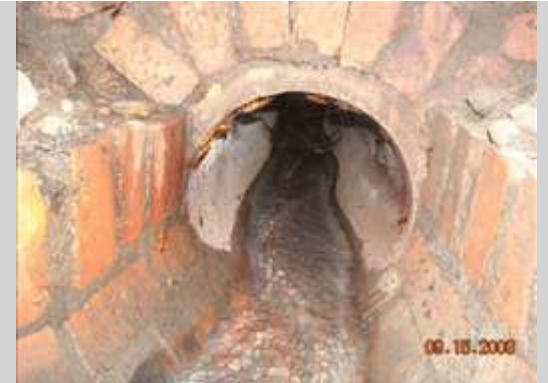
10 in. Circular Gravity Sewer Pipe Out @ 12 O'Clock

Infiltration: **Evidence** Pipe Seal Cond: **Unknown**

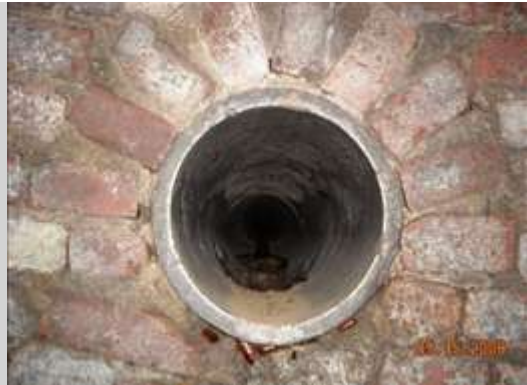
Pipe In @ 9 O'Clock

Deposits: ☐ None ☒ **Mud** ☐ Sludge ☒ **Debris** ☐ Grease

Silt Depth: **3** (in.)

Deposits Extent: **Medium**

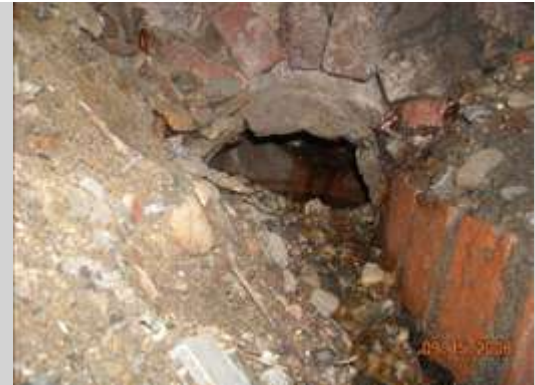
Drop In @ 9 O'Clock

Drop Condition: **Partly Clogged**
